mcHF Hardware modifications as of November 27, 2014
as compiled by KA7OEI for
Version 0.3 UI and Version 0.4 RF boards

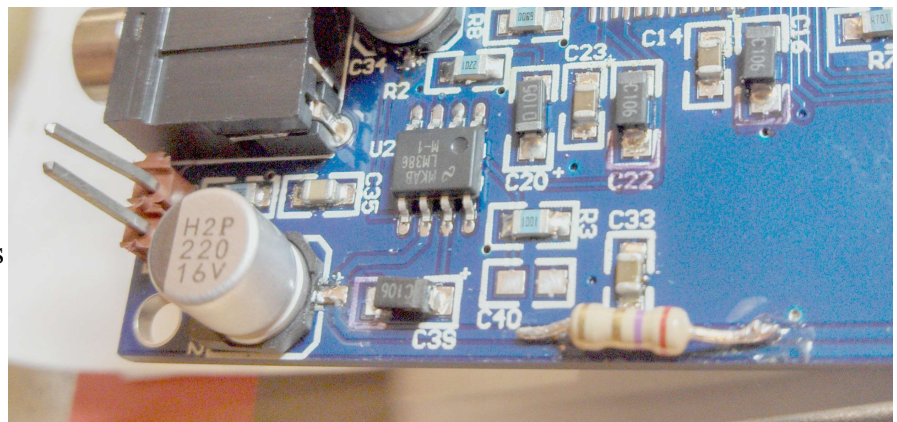
This modification prevents audio from appearing on the 8 volt line which, in turn, causes audio to appear on the ground busses and other power supplies in the radio which can cause feedback, particularly at high volume levels with wider audio filters.

The 4.7 ohm resistor added to the UI_8V line feeding U2, the audio amplifier.

The insertion of a 4.7 ohm, 1/2 watt resistor in series (or two 10 ohm 1/8 watt resistors in parallel) with the +8 volt line, near the LM386 audio amplifier.

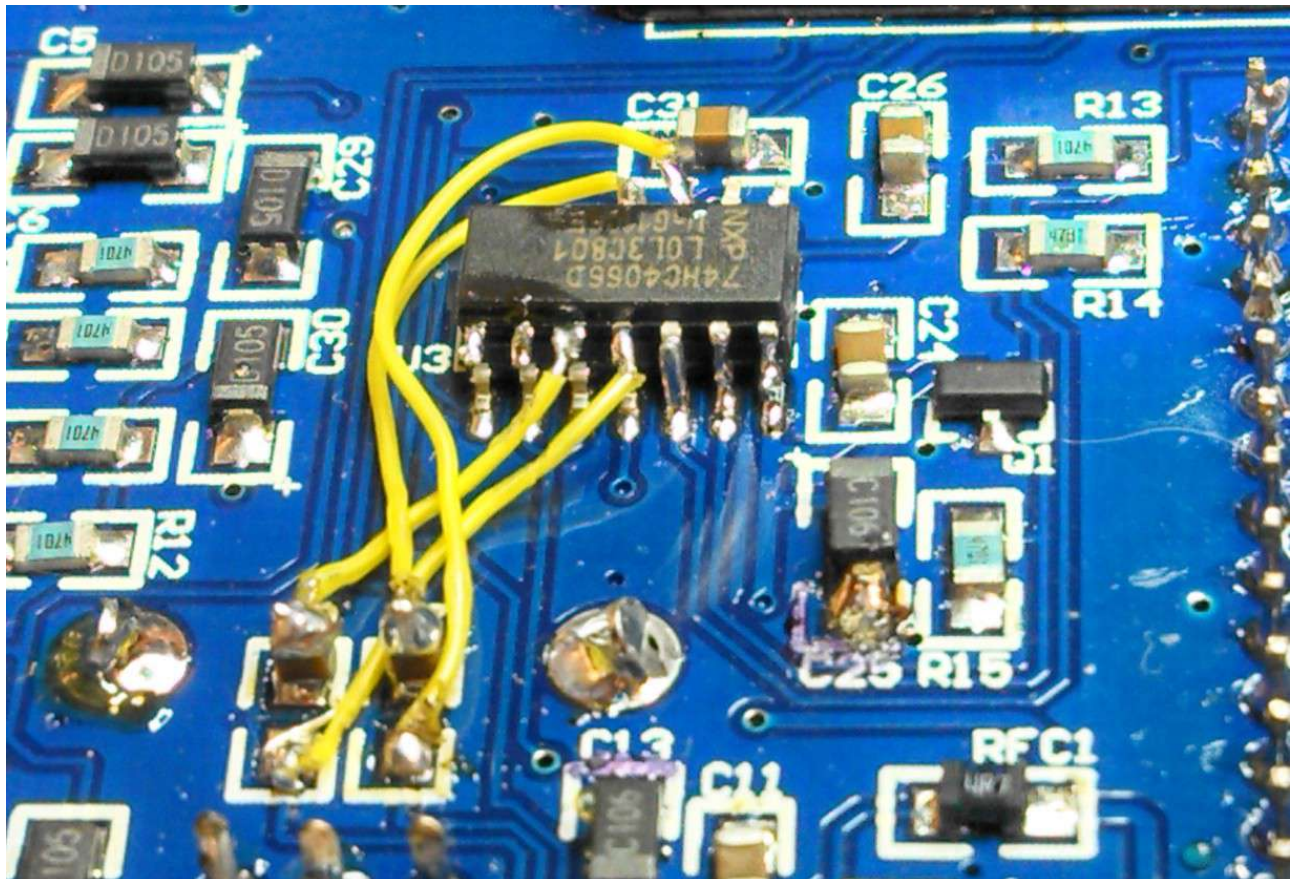
This fixes a source of distortion/oscillation in the receiver, particularly at high volume levels and on high bands: **This is a very important modification that all users of this transceiver should perform.**

The "U3a" modification, piggybacking another 74HC4066 atop U3 to prevent feedback into the receiver.

This modification prevents “breakthrough” of the TX QSD mixer (U17) caused by the fact that the Codec's DA is shared both for RX audio and TX modulation. Because the audio drivers for the TX modulator (U20-U23) are powered from 8 volts it is possible for high RX level audio to violate logic levels at U17, turning it “on” on voltage peaks: The result of this is highly-distorted, on-frequency noise/feedback.

Take a 74HC4066 chip, of the same type and package as U3 and piggyback it atop U3 (on the UI board) and use its power supply and control signals. This chip will now be able to turn on/off the TX I and Q signals with a bit of fairly simple rewiring. Let us call this new chip "U3a"

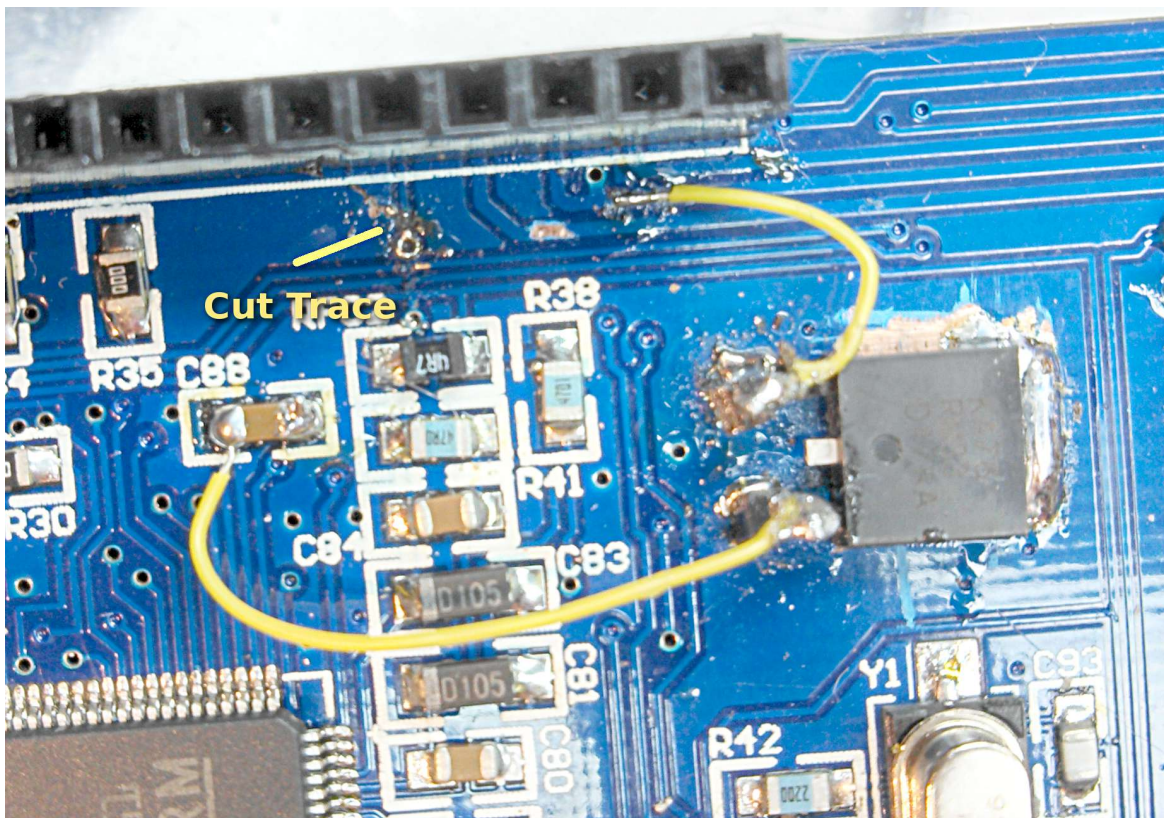
The added 3.3 volt regulator to deliver an isolated power supply to U4a, the MCU. This reduces a noise source that can get into low-level RF and audio stages. The trace is cut just above the via. Note that this picture was taken before the addition of the 4.7 ohm resistors and additional capacitors described below and is included for clarity.

The trace to isolate the 3.3 volt supply feeding the MCU is indicated on the picture and it should be cut **just above the via** that goes through to the other side of the board. The 3.3 volt output from the added regulator is shown connected to the left-hand side of C88, below.

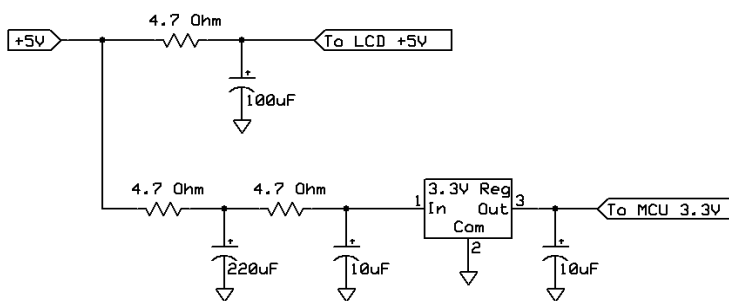
While the regulator's contribution directly to the 3.3 volt line was significant and moving it to the 5 volt line made a significant improvement, it still put noise on the 5 volt bus which powers devices many other low-level circuits, such as the QSD mixers and, to a lesser degree, the RF signal sources (e.g. local oscillators.)

Diagram of the filter/regulators of the LCD and MCU power supplies. A low-dropout 3.3 volt regulator is used.

The 220uF capacitor on the input side of the 3.3 volt regulator, along with the 4.7 ohm resistors, form a low-pass filter that provides an impedance path between the noise source at the input of the regulator and the capacitor, greatly improving its ability to filter. The other 4.7 ohm resistor provides isolation between the noise that remains at the 220 uF capacitor and the rest of the 5 volt bus in the transceiver.

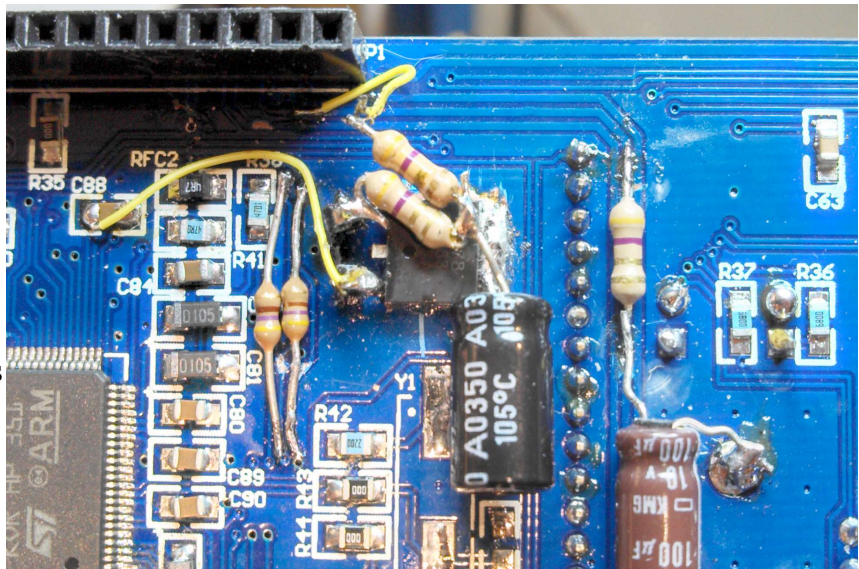
With the increase in sensitivity due to the reduced receiver background noise there may be the additional tendency for audio feedback to occur at high volume levels, particularly with no antenna connected *when using a speaker*. This is related to circulating currents on the UI board, some of which were addressed with the addition of the 4.7 ohm resistor in series with the 8 volt line on U2 noted earlier in this document.

Increasing the capacitance of C32 to 1000uF can reduce this effect, as can the use of headphones or an external audio amplifier. The modifications showing the 3.3 volt regulator (center) and the additional filtering of the 5 volt LCD line (right). The resistor to filter the "tick" (see next section) are also visible.

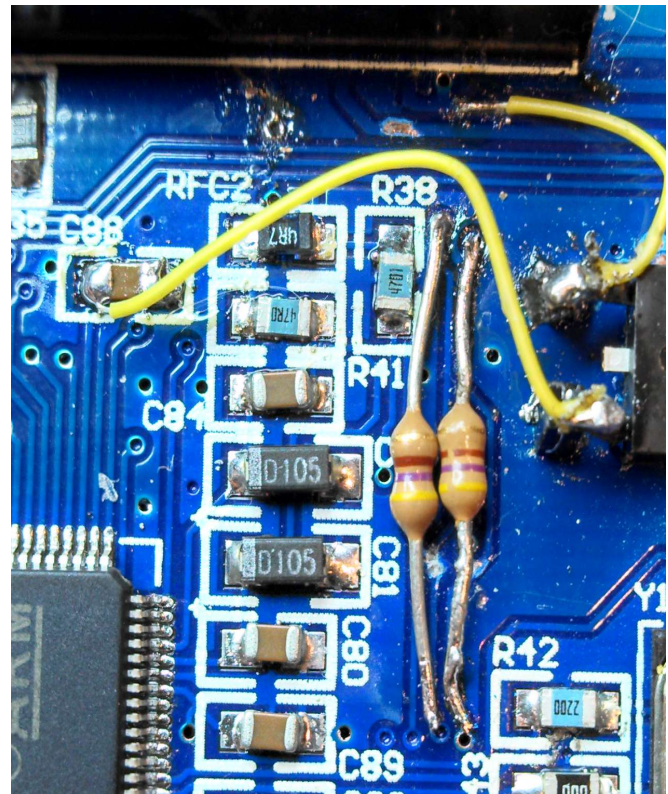
This modification appears to be *completely* effective in removing the “tick” noise from the higher bands and does not appear to compromise the operation of the I2C data stream in any way.

The added 470 ohm resistors in series with the SCL and SDA lines. Note that this picture also shows the added 3.3 volt MCU regulator mentioned above. 1/8 watt, leaded resistors are used, but surface mount resistors could be used, if desired.

In the picture can be seen the two added 470 ohm resistors. As you can see, I used leaded 1/8 watt resistors, but surface mount resistors can be used, instead if that is your preference. (The 3.3 volt regulator used for the MCU – see the modification earlier in this document – can be partially seen.)

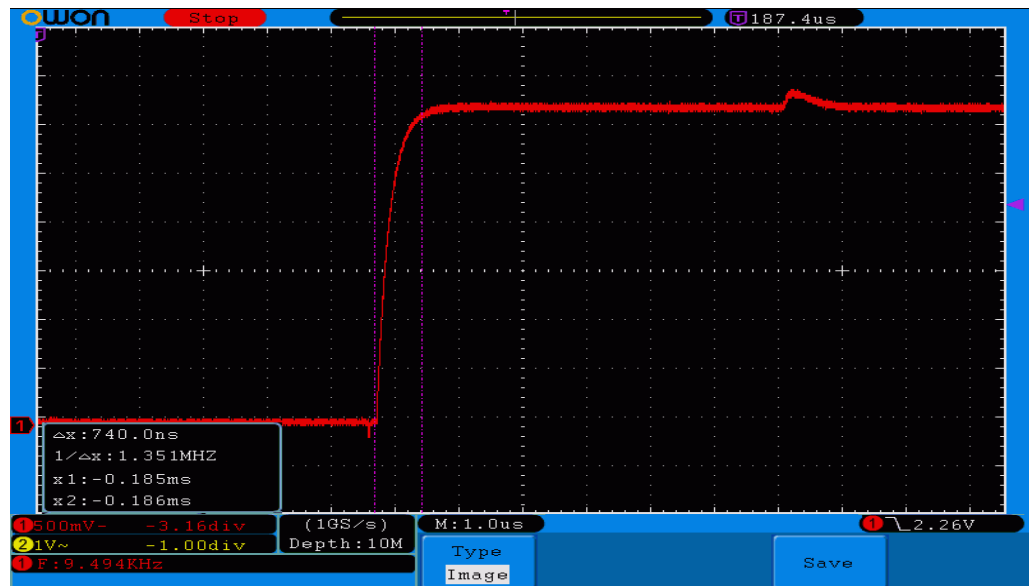
As can be seen, the risetime is less than 740 ns at the 10%-90% points which is a fraction of the I2C clocking rate, well within the time at which the edge of the clock into which the data is strobed in by the peripheral.

*Of the rise and fall times on the I2C, the slowest slew rate was the **rise** time shown in this digital oscilloscope capture, which is well within the acceptable time for the clocking rate!*
